Channel-Floodplain Disconnection on the Stanislaus River: A Hydrologic and Geomorphic Perspective

ABSTRACT. The Stanislaus River, the northernmost major tributary to the San Joaquin River, has undergone profound alterations to its flow regime, channel form, and ecosystems. New Melones Dam (built in 1979) and over 30 smaller dams cumulatively impound 240% of average annual unimpaired runoff, reducing winter floods and spring snow melt runoff, and increasing summer base flows to supply irrigation demand. The frequency and extent of overbank flooding has consequently been reduced. Aerial photographs document reduced channel complexity and extensive encroachment of riparian vegetation into the formerly active channel from 1937 to 1998. Limited historical data and field evidence suggest the channel incised approximately 1-3 ft. since dam construction, so the discharge needed for overbank flows has approximately doubled, further isolating floodplains from the channel, and leading to the loss of important habitats. To reestablish overbank flooding and its attendant ecological benefits, both re-operating New Melones Dam to increase high flows in the river, and setting back or breaching le

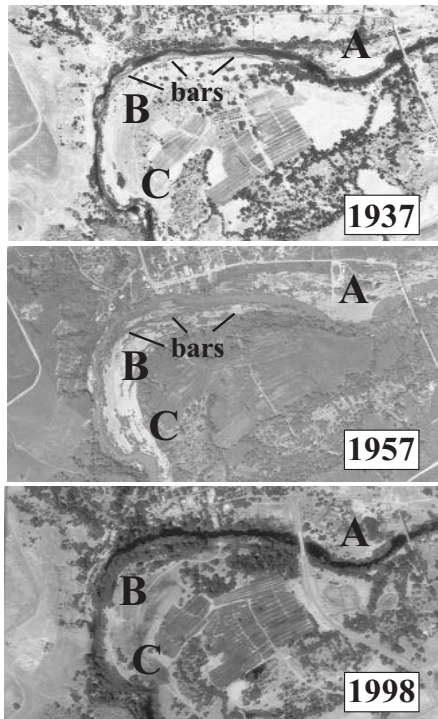
Figure 6 ▲ N 0 1,000 ft.

FIGURE 6. Sequential Aerial Photographs of the Stanislaus River near Knight's Ferry. A 1937 aerial photograph shows unvegetated alternative bar sequences adjacent to the river channel, suggesting frequent scour by high flows. In 1957, evidence of scour and deposition from the 1955 flood includes lack of vegetation development along the banks and bars, and deposition of sand and gravel on the bars and floodplains. In contrast, by 1998, open gravel bars had disappeared and were replaced by dense, riparian vegetation on the banks. A gravel pit (approximately 2,600 yd²) is visible at point D and was evidently partially refilled by deposition of bedload.

Knight's Ferry Reach (RM 54.7 to 53.1)

Sequential air photographs from 1937-1998 near Knights Ferry (RM 54.7 to RM 53.1) illustrate the nature of channel changes that have occurred on the Stanislaus River (Figure 6). In 1937, unvegetated alternating bar sequences adjacent to the river channel were visible, with discontinuous woody bank vegetation, and unvegetated point bar (A) on the left bank, and open gravel bars at B, C, and D suggesting frequent scour by high flows. The 1957 aerial photograph likewise showed an unvegetated active channel and apparently fresh deposition of sand and gravel on the bars and floodplains, presumably due to flood scour (including the effects of a peak flow of 62,900 cfs in December 1955).

By 1998, the unvegetated alternating bars had disappeared, and dense, riparian vegetation armored the banks, forming a continuous wall along the channel. The bar at point B was completely obscured by vegetation and the large bar at point C was fringed by a wall of vegetation. A gravel pit at point D appeared to be partially refilled by deposition of sediment.

Overall, air photos from 1937-1998 show extensive vegetation encroachment in the formerly active channel reflecting a reduction in frequency of flood

scour in the channel. Similarly, point bars and floodplain surfaces show less evidence of flood scour. The air photos also show substantial encroachment by urban and agricultural development, particularly orchards, in floodplain areas, thereby altering the natural river channel/floodplain connection.
